NASA Technical Paper 1042

Light Airplane Crash Tests
at Impact Velocities
of 13 and 27 m/sec

Emilio Alfaro-Bou and Victor L. Vaughan, Jr.

NOVEMBER 1977

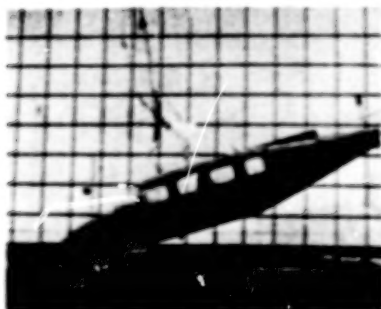
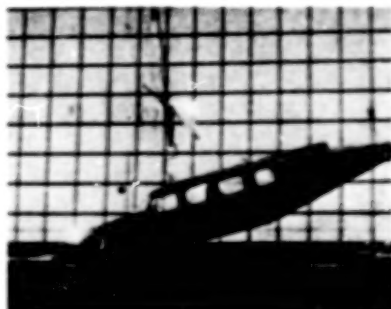
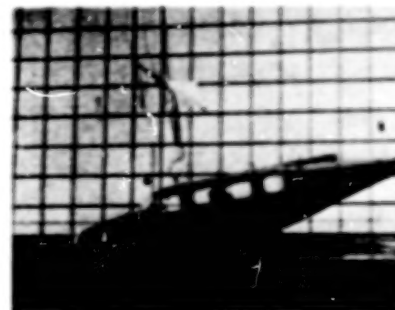
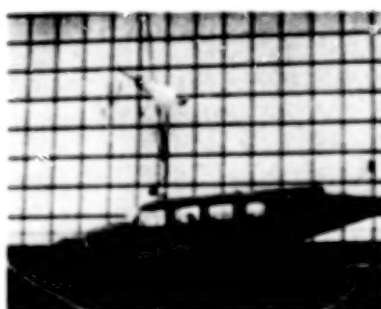
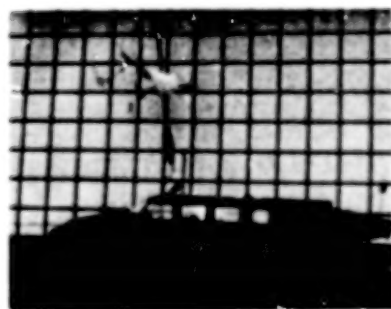
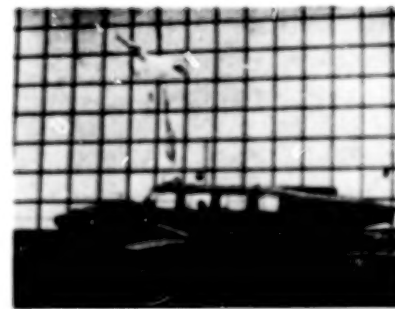
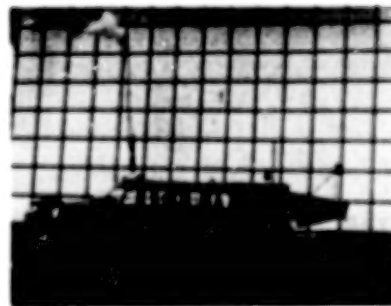
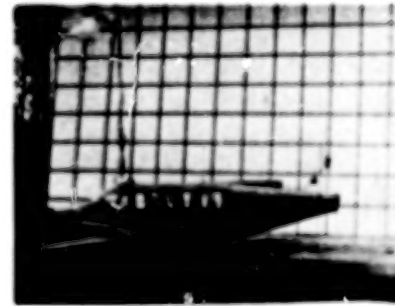
(a) Test 1.

Figures 8(a) and 8(b) are sequences of photographs taken during the first and second test, respectively. Time between frames is 0.05 second. The photographs clearly show the free-flight condition of the test specimen prior to initial impact. The structural damage to the fuselage occurs during two impacts: initial impact followed by a second impact. Initial impact starts when the nose first contacts the landing surface (second frame in test 1 and third frame in test 2). Second impact starts at the time the wing main spar contacts the landing surface (fifth frame). During initial impact, the floor beams in the nose yielded and caused buckling of the nose and fire wall. The combination of downward momentum of the wings and the impact of the main spar with the ground caused twisting of the main spar and loss of wing dihedral angle. For both tests, the structural damage was moderate and the cabin maintained its integrity and liveable volume.

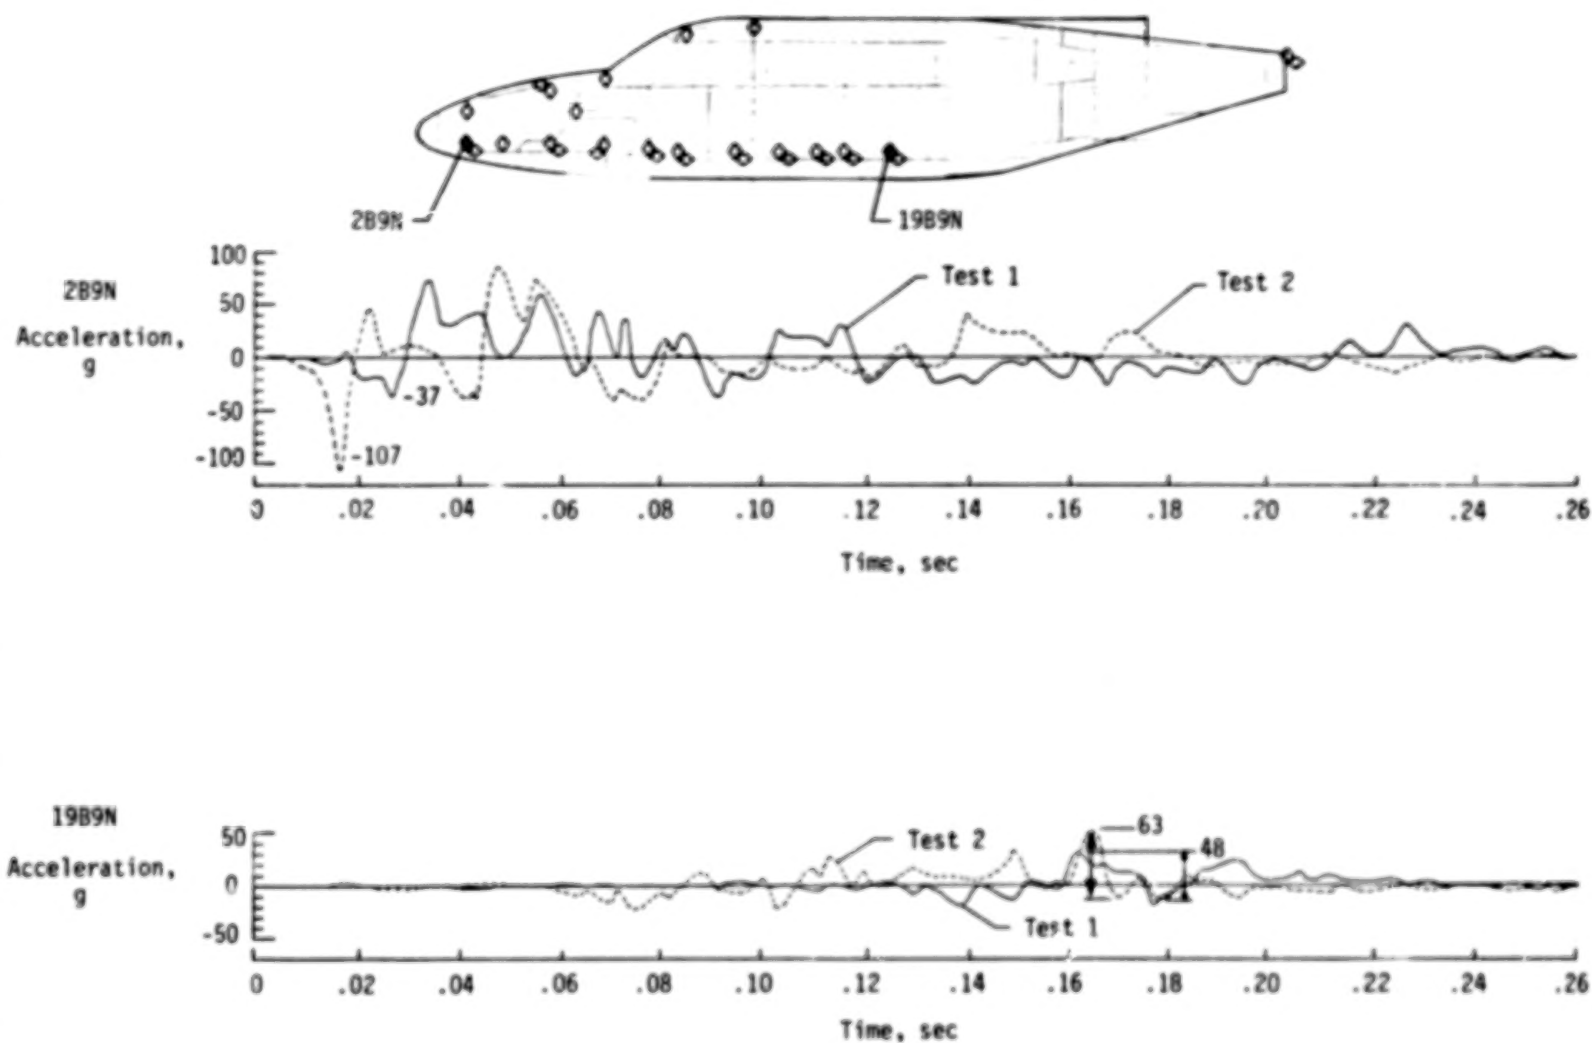
(a) Accelerations at two extreme points.

Acceleration traces in the normal (Z-axis) direction for two extreme points on the floor beam are shown in figure 9(a). The top traces are the acceleration time histories produced by the initial impact in the nose area at point 2B9N. The trace for test 1 (solid line) shows a peak of -37g occurring 26 ms after initial ground contact whereas in test 2 (dashed line) a peak of -107g was recorded 18 ms after contact. The minus signs signify accelerations in the upward direction. ($1g = 9.806 \text{ m/sec}^2$.) After initial impact, the

As the specimen continues to slide forward, the cabin rotates onto the landing surface. The impact in the rear of the cabin was recorded by accelerometer 19B9N located adjacent to the floor beam. A peak-to-peak acceleration of 48g was recorded in test 1 at this location and 63g in test 2. (See fig. 9(a).) Significant accelerations recorded at the rear of the cabin (location 19B9N) do not appear until 125 ms after initial contact in test 1 and after 60 ms in test 2. Acceleration time histories adjacent to the floor beam normal to the longitudinal axis are shown in figures 9(b) and 9(c) for tests 1 and 2, respectively. From top to bottom the traces represent nose to tail accelerometer locations. The higher acceleration peaks of each trace occurred when that location on the floor beam was over the fuselage-ground contact point. Zero time represents initial contact. In test 2 (fig. 9(c)) at twice the impact velocity of test 1, the accelerations were higher and the elapsed time for significant accelerations was of shorter duration.

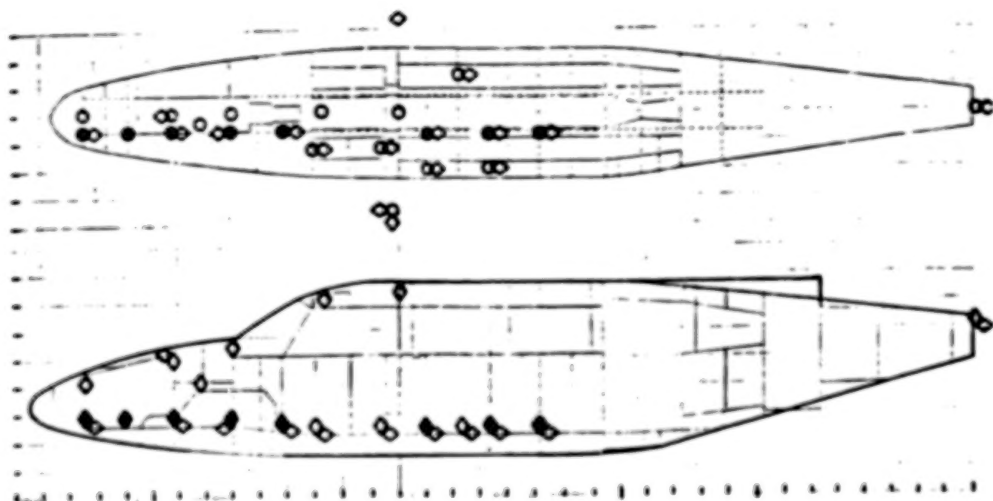
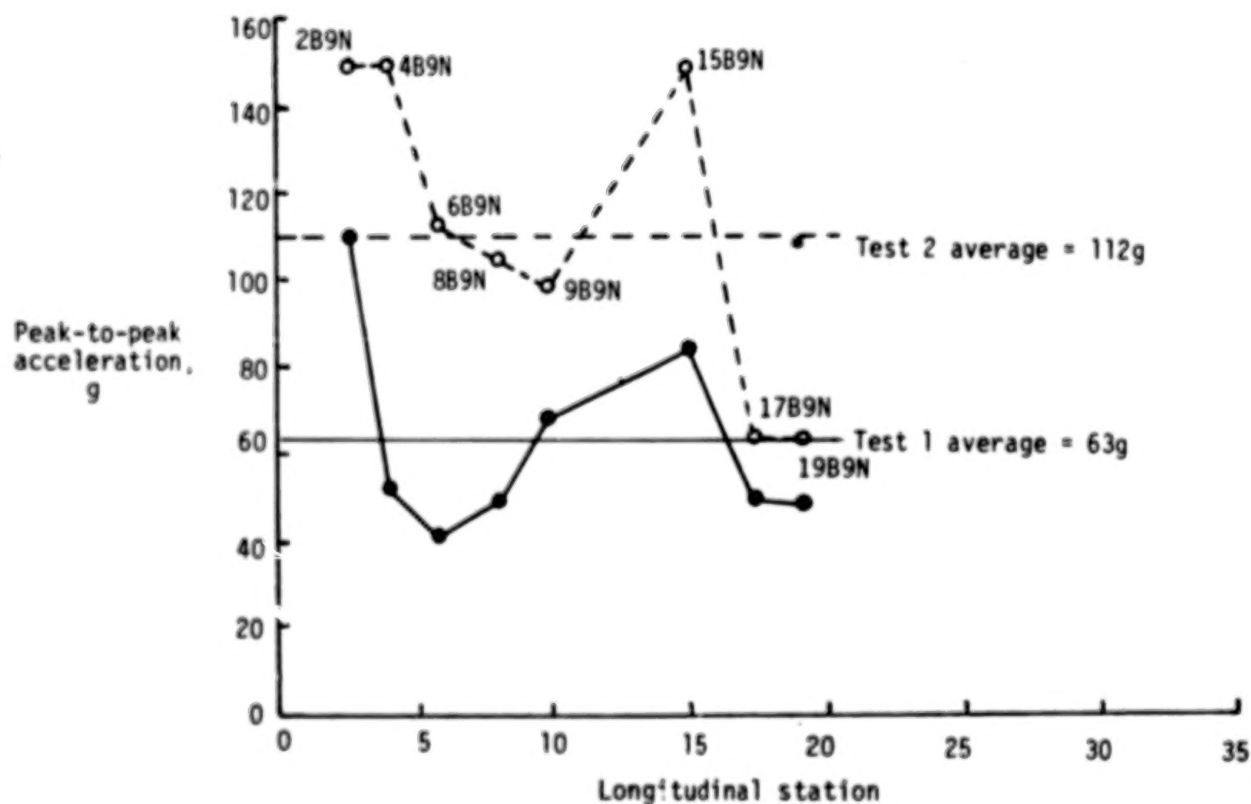
(a) Normal accelerations adjacent to floor beam.

The peak-to-peak normal accelerations on the roof (location 14G9N, fig. 12(c)) and adjacent to the floor beam (location 15B9N, fig. 12(a)) are 36g and 85g, respectively, for test 1 and 80g and 150g for test 2. In this comparison, the roof accelerations are 58 percent lower than those at the floor beam for test 1 and 47 percent lower for test 2. The lower roof accelerations reflect the effect of fuselage shell deformations and load alleviation as discussed for figure 11. After the impact was over, the cabin structure returned approximately to its original shape, but the floor beams remained deformed. In this test the apparent floor beam protrusion resulted in a slight rotation of the seats toward their respective side windows as shown in figure 11(d).

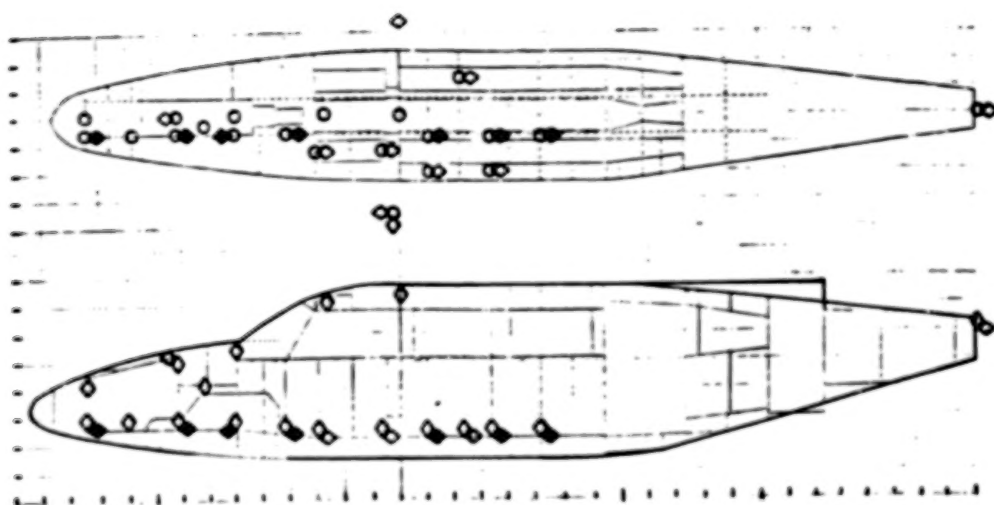
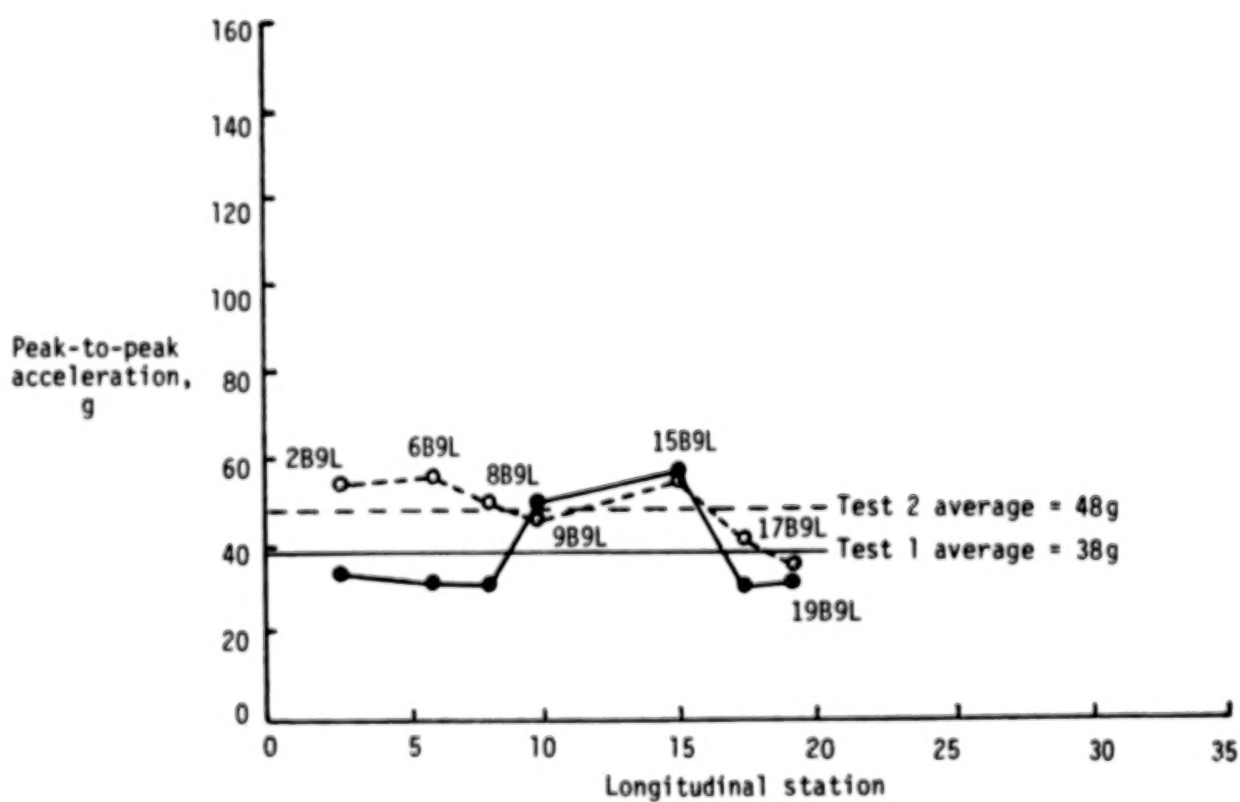
(b) Longitudinal accelerations adjacent to floor beam.

The average values of the longitudinal peak-to-peak accelerations at locations adjacent to the floor beam are shown in figure 12(b) and were approximately 40 percent lower than the normal acceleration value in corresponding locations for test 1 and 57 percent lower for test 2. In test 1 the peak-to-peak longitudinal values were higher near the main spar and correspond to high normal acceleration values at the same location. In test 2, the average value of longitudinal peak-to-peak accelerations was 26 percent higher than in test 1.

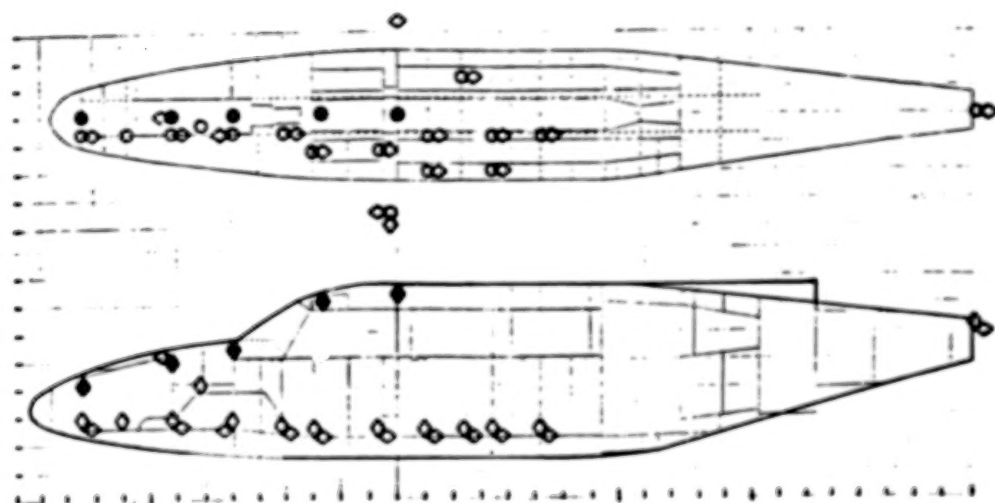
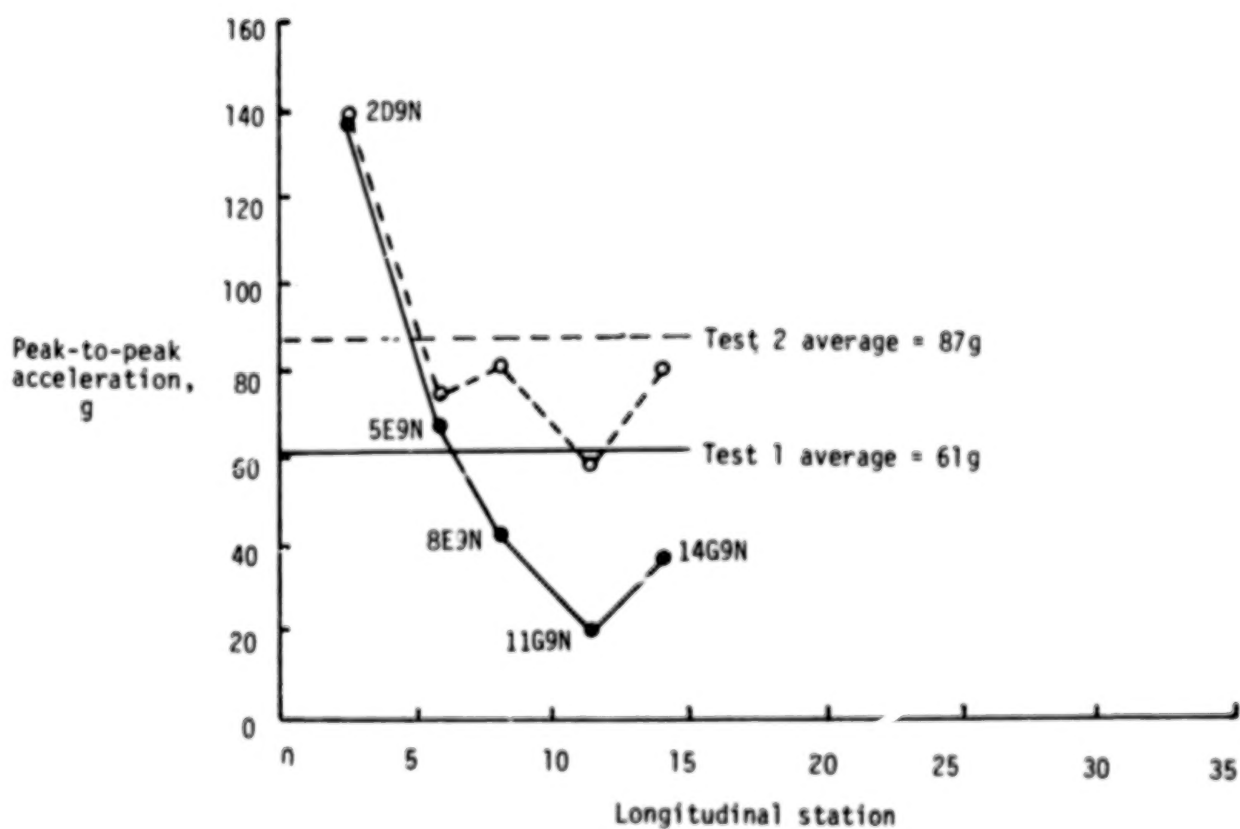
(c) Normal accelerations on roof.

The peak-to-peak accelerations normal to the roof were higher in the nose area. Average values were 43 percent higher in test 2 than in test 1 and are shown in figure 12(c). Figures 12(d) and 12(e) show the peak-to-peak accelerations on the cabin floor in the normal and longitudinal directions, respectively. In test 2 both the normal and longitudinal peak-to-peak accelerations were approximately 52 percent higher than in test 1.

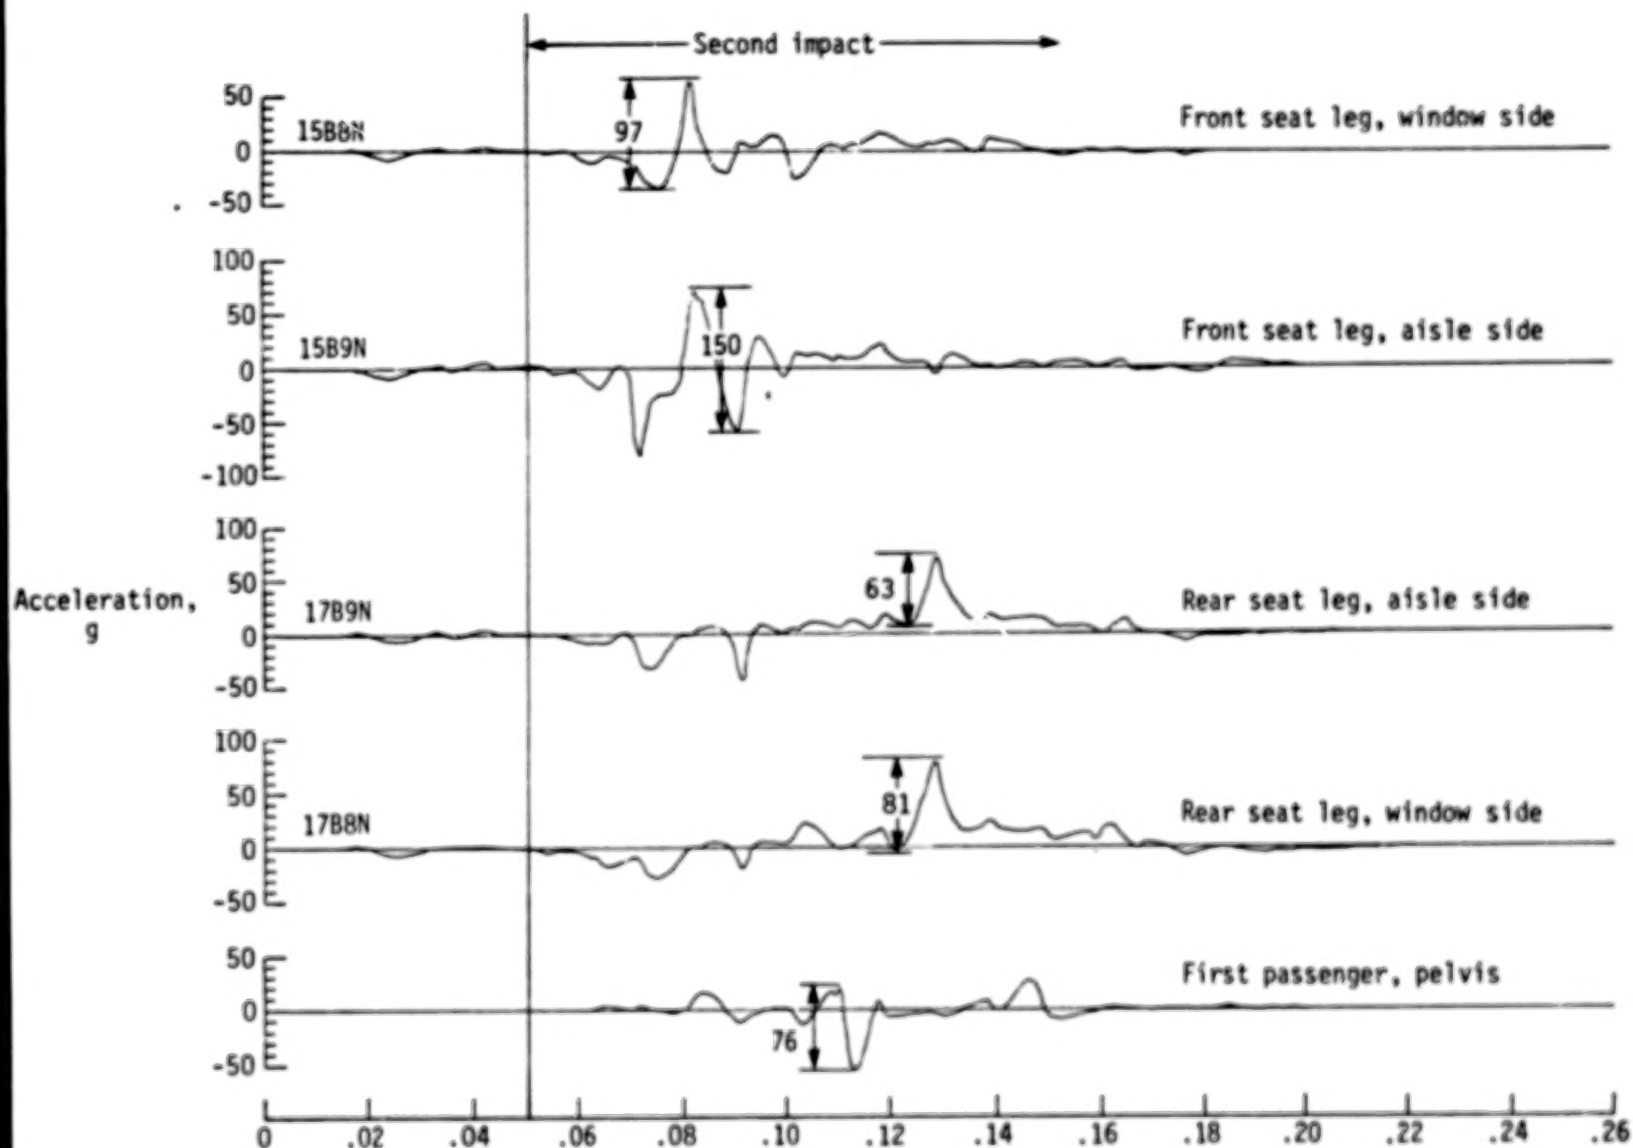
(a) Test 1.

Figure 13 is a plot of the normal accelerations on the floor at the base of the first passenger seat. The time of main spar contact with the ground was determined photographically and is superimposed on the traces for reference. In test 1 (fig. 13(a)) and in test 2 (fig. 13(b)) the combined effect of structural deformation, angular acceleration, and timing produces higher peak-to-peak accelerations on the cabin floor at the front seat legs compared with the accelerations at the rear seat legs. Also during second impact the peak-to-peak accelerations on the floor were higher on the aisle side than those on the

In test 2, the peak-to-peak acceleration at the dummy pelvis along the spine was 76g (fig. 13(b)). In test 1 the dummy pelvis was not instrumented. Although a direct comparison between normal peak-to-peak accelerations on the floor and on the dummy pelvis could not be made because the orientation of the accelerometer along the spine changed with dummy motions during the test, it appears that some energy dissipation or force alleviation has taken place due to seat deformation. The front seat legs are experiencing peak-to-peak normal accelerations of 97g and 105g. (The rear seat legs are averaging closer to normal peak-to-peak accelerations of 72g.)
